TECHNICAL REPORT M-85 10

April 1985

Rapidly Erectable and Relocatable Lightweight Structures

## **Field Testing of a Lightweight Relocatable Structure in a Temperate Environment**

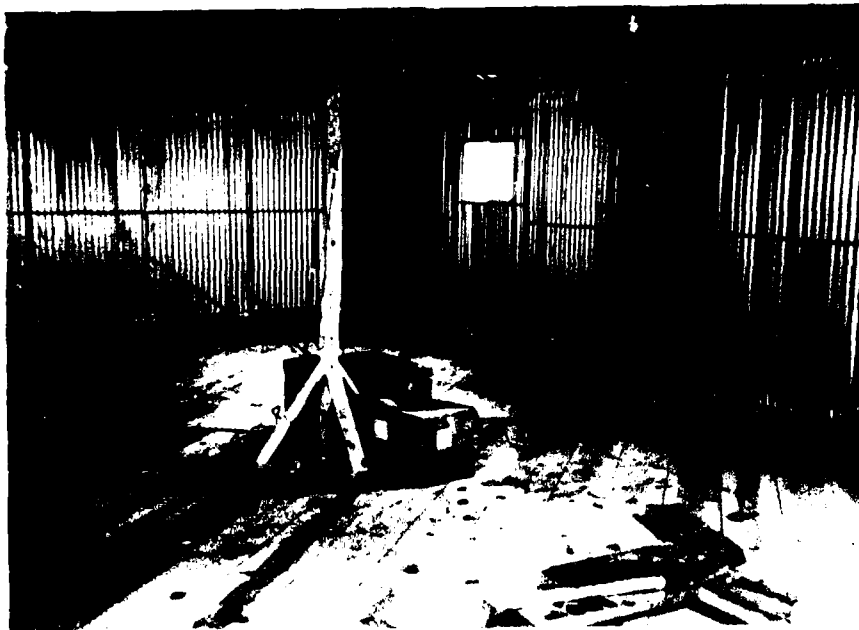
**Figure 16.** Interior of the control building.

elevated endwall is shown in Figure 15. Erecting the panels by manually rolling up the 4-ft-wide bay sections was difficult and hazardous on the elevated foundation. (Using a crane is, thus, highly recommended when installing the structures on an elevated foundation.) The interior of the completed control building is shown, with instrumentation in place, in Figure 16.

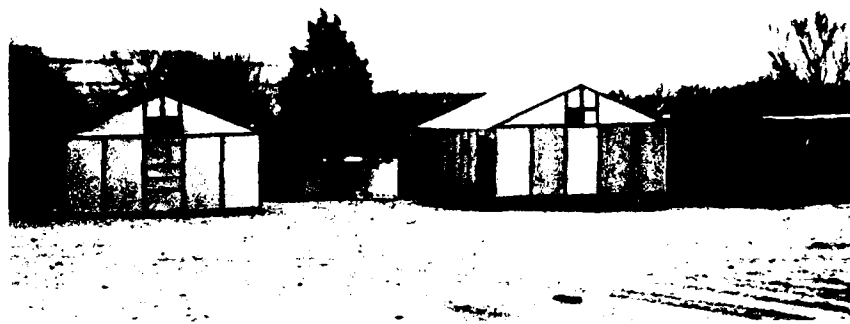
**Figure 4.** Test structure and control structure on elevated wood baseplates.

Two 20- x 40-ft baseplates were built on separate semi-permanent elevated wood foundations at the start of the test (Figure 4). The foundation consisted of heavy (8- x 8-in.) perimeter beams, 2- x 6-in. flooring supports, and 1- x 12-in. board floors (Figure 5). The foundation was erected on a slight
